SVE BULLETIN

2013 Sedan & Utility Police Interceptors Rear Seat Rear Window Control Disable

This bulletin provides information to upfitters to disable rear window control from the rear seating position and allow rear window control from front driver position only.

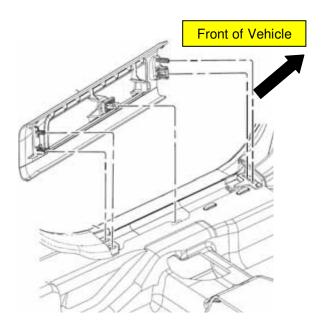
Open the driver side front door. Starting at the rear of the scuff, lift the scuff plate to release the retention clips. Work forward lifting up on the scuff plate until it's completely detached from the vehicle. Place scuff on the front floor for reinstallation.

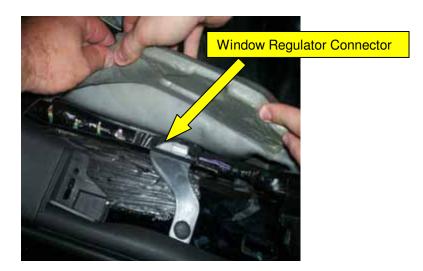
With the scuff plate removed, pull back the carpet to reveal the wire harness as shown. Locate the grey connector in the harness bundle as shown. Pull back the electrical tape enough to remove the grey connector.

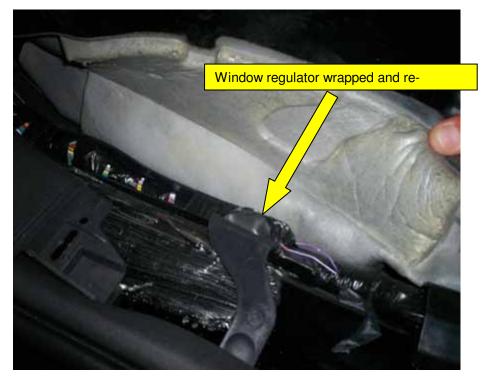
Place the connectors back down into the harness bundle as shown.

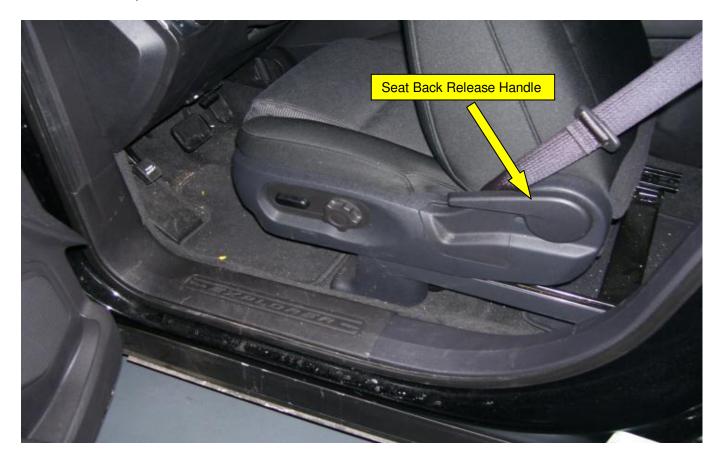
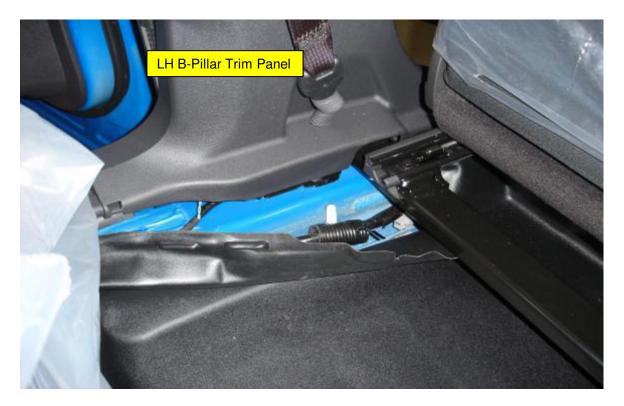
Adjust the front driver seat to the fully forward location. Position the seat back against steering wheel using seat back release handle located on the outboard side of the seat, to gain access to the lower "B" pillar trim.

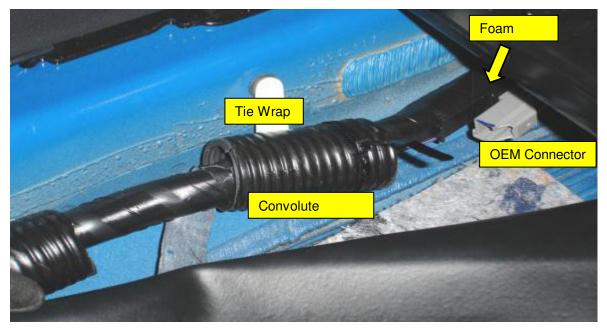
Depress tab & unplug connector. Tuck connector into convolute sleeve located on existing body harness. Tie wrap connector wire around body harness at location shown. Apply (1) piece of foam tape (P# 5F93- 23726-AB) over connectors to seal ends. Trim off excess tie wrap tab with wire cutter, discard tab. (Not shown)

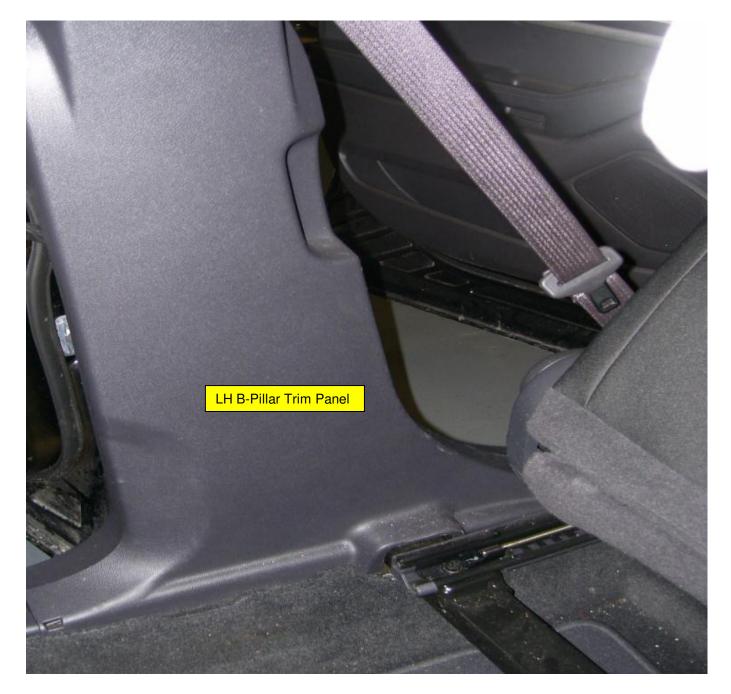
Starting from the bottom of the LH B-pillar. Tuck floor mat or carpet back underneath the lower B-pillar trim panel, rear sill plate as shown. Verify floor mat or carpet fit & appearance upon installation.
